**Flood Control Project Maintenance  
Levee Inspections**

## Maintenance Issue Types Only, Levee Inspection Report By Mile - Fall 2015

### Reclamation District No. 2062 Stewart

Waterway	Bank	Unit Miles	Inspection Start/End	Inspector
Unit No. 01 San Joaquin River	Left	2.64	10/14/2015 10/14/2015	Maksim Khashchuk

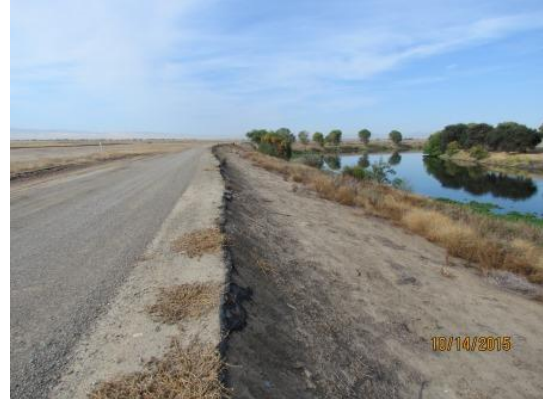
Photo 1 of 1 : FA\_2015\_RD2062\_309\_7\_20151026\_00004.jpg

LM Start	0.53	Rating **	A	Issue No.	7
LM End	0.53	Issue Type +	Ma	Location *	WS
Category	Earthen Levee			GPS Latitude/Longitude	
				Start	End
Item	Vegetation			37.805038 °	37.805038 °
				-121.319932 °	-121.319932 °
DWR ID	DWR_RD2062_01_f_2015_7				
Action/Comments					
Control annual grass and weeds on the levee slopes and easements.

View of the acceptable vegetation control on the waterside levee slope.

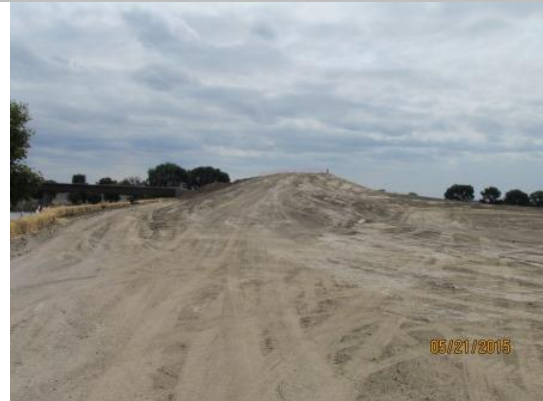
Photo 1 of 1 : FA\_2015\_RD2062\_309\_6\_20150910\_00001.jpg

LM Start	0.72	Rating **	A/W	Issue No.	6
LM End	0.72	Issue Type +	Ma	Location *	WS
Category	Earthen Levee			GPS Latitude/Longitude	
				Start	End
Item	Crown Surface / Depressions / Rutting			37.805138 °	37.805138 °
				-121.316420 °	-121.316420 °
DWR ID	DWR_RD2062_01_s_2015_6				
Action/Comments					
Add appropriate gravel or road base. Grade and compact. Inspector Comments: New levee patrol road is being installed. Make sure all-weather access is available before next flood season.

View of the new patrol road installation in process.

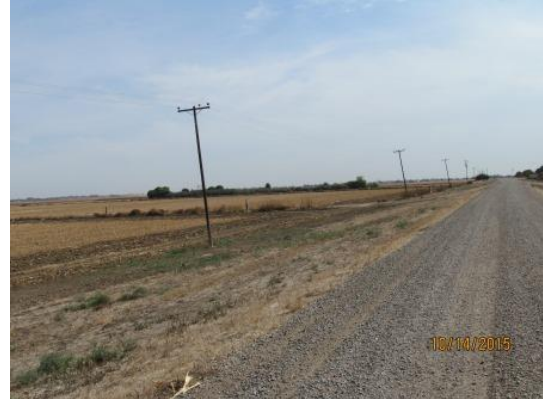
Photo 1 of 1 : FA\_2015\_RD2062\_310\_12\_20151026\_00013.jpg

View of the acceptable vegetation control on the landside levee toe.

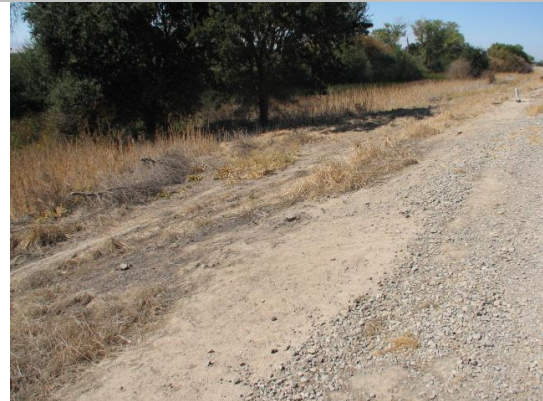
Photo 1 of 1 : FA\_2015\_RD2062\_310\_3\_20150910\_00001.jpg

LM Start	2.84	Rating **	N	Issue No.	3
LM End	2.84	Issue Type +	Ma	Location *	WS
Category	Earthen Levee			GPS Latitude/Longitude	
				Start	End
Item	Trim / Thin Trees			37.803827 °	37.803827 °
				-121.372424 °	-121.372424 °
DWR ID	DWR_RD2062_02_s_2012_3				
Action/Comments					
Tree stumps.					
Inspector Comments: Three small tree stumps.

Three small stumps on levee slope.

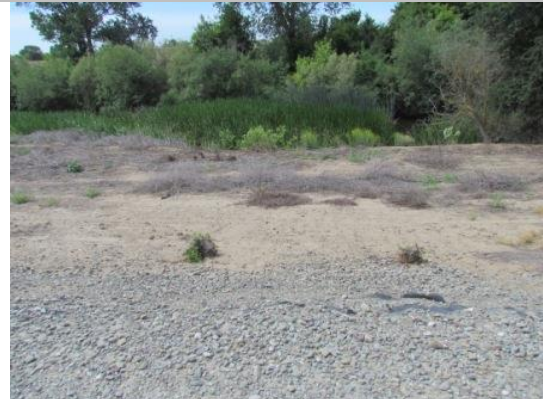
Photo 1 of 1 : FA\_2015\_RD2062\_310\_13\_20150910\_00003.jpg

LM Start	2.88	Rating **	N	Issue No.	13
LM End	2.88	Issue Type +	Ma	Location *	WS
Category	Earthen Levee			GPS Latitude/Longitude	
				Start	End
Item	Trim / Thin Trees			37.804060 °	37.804060 °
				-121.373245 °	-121.373245 °
DWR ID	DWR_RD2062_02_s_2012_13				
Action/Comments					
Tree stumps.					
Inspector Comments: Four small oak stumps on levee slope.

View of tree stumps on waterside slope. 05/17/2012

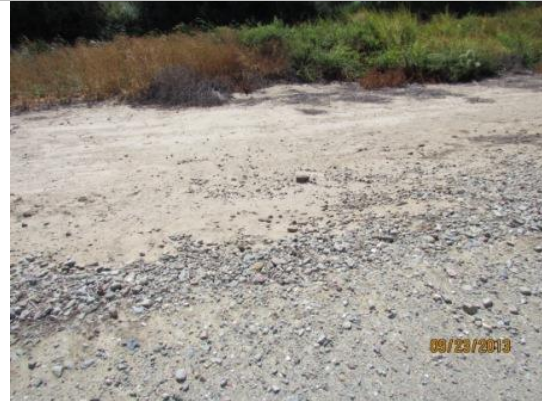
Photo 1 of 1 : FA\_2015\_RD2062\_310\_14\_20150910\_00004.jpg

View of the tree stump in the middle of the photo.

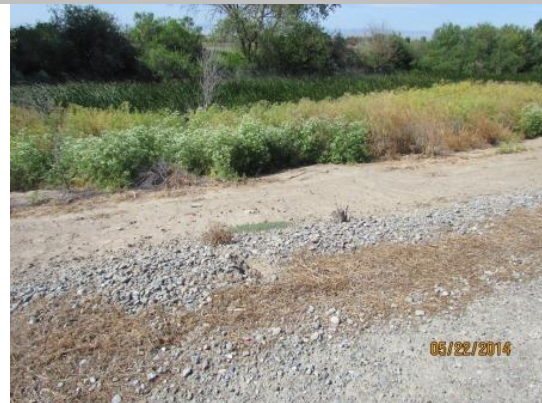
Photo 1 of 1 : FA\_2015\_RD2062\_310\_15\_20150910\_00005.jpg

LM Start	3.01	Rating **	N	Issue No.	15
LM End	3.01	Issue Type +	Ma	Location *	WS
Category	Earthen Levee			GPS Latitude/Longitude	
				Start	End
Item	Trim / Thin Trees			37.804481 °	37.804481 °
				-121.375510 °	-121.375510 °
DWR ID	DWR_RD2062_02_s _ 2012_15				
Action/Comments					
Tree stumps.

View of the tree stumps on the waterside levee slope.

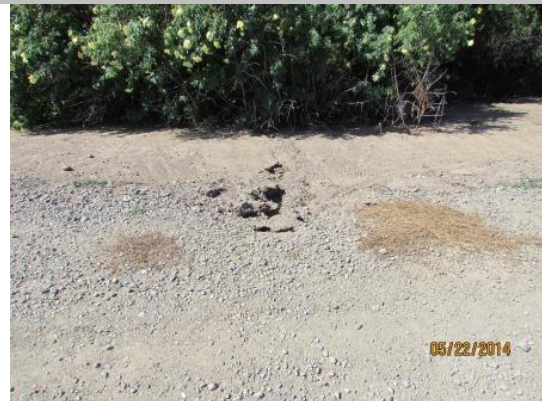
Photo 1 of 1 : FA\_2015\_RD2062\_310\_8\_20150910\_00002.jpg

LM Start	3.64	Rating **	M	Issue No.	8
LM End	3.64	Issue Type +	Ma	Location *	WS
Category	Earthen Levee			GPS Latitude/Longitude	
				Start	End
Item	Erosion / Bank Caving			37.806347 °	37.806347 °
				-121.386692 °	-121.386692 °
DWR ID	DWR_RD2062_02_s _ 2014_8				
Action/Comments					
Schedule repair of erosion site prior to the next inspection.

View of the erosion from surface runoff on the waterside levee slope.

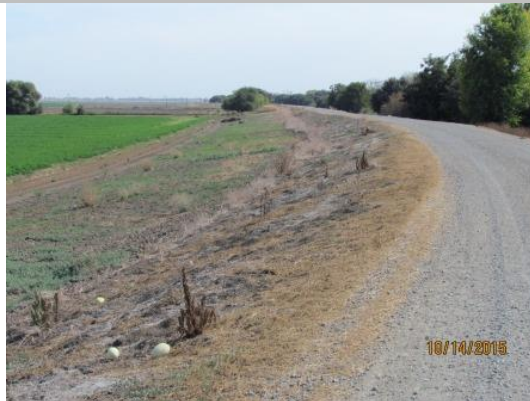
Photo 1 of 1 : FA\_2015\_RD2062\_310\_11\_20151026\_00012.jpg

View of the acceptable vegetation control on the landside levee slope.

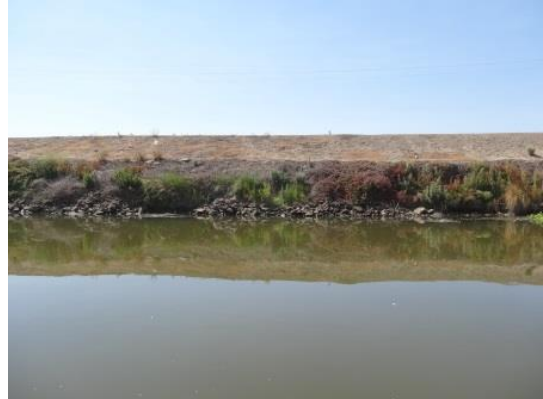
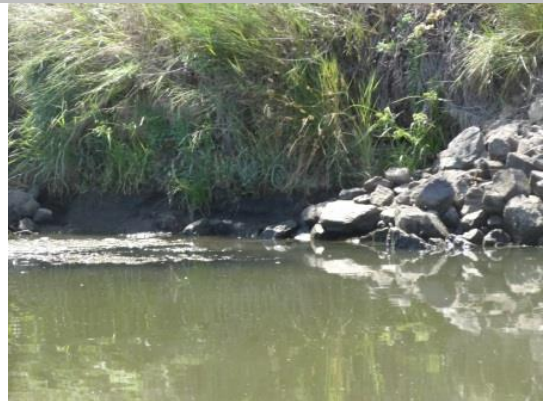
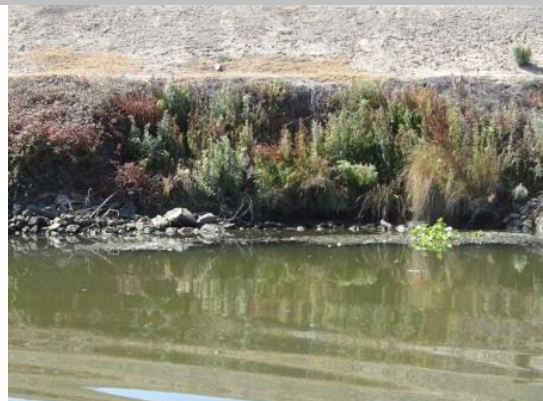
LM Start	0.00	Rating **	U	Issue No.	8
LM End	0.09	Issue Type +	Ma	Location *	WS
Category	Supplemental			GPS Latitude/Longitude	
				Start	End
Item	DWR Erosion Survey			37.809673 °	37.809673 °
				-121.390321 °	-121.390321 °
DWR ID					
Action/Comments					
Inspector Comments: 06/25/2015: No significant change observed. 07/02/2014: No significant change observed. 08/13/2013: No significant change observed. 08/07/2012: The site has been visited by boat survey. No significant change observed 08/23/2011: Site is at the upstream of a drainage ditch. [2015 Site ID:RD2062U03RM29.93]

Front view of the erosion.

Close view of the erosion.

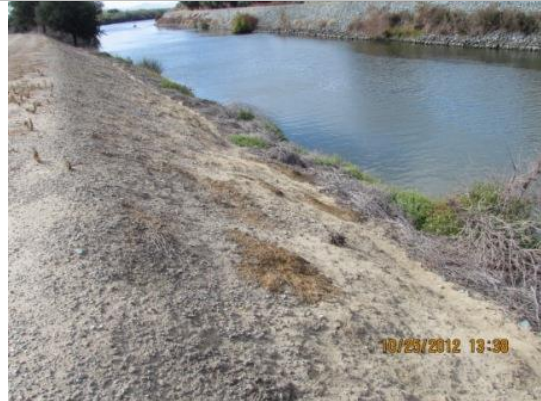
Photo 1 of 1 : FA\_2015\_RD2062\_311\_3\_20150910\_00003.jpg

View of tree stumps on waterside slope.

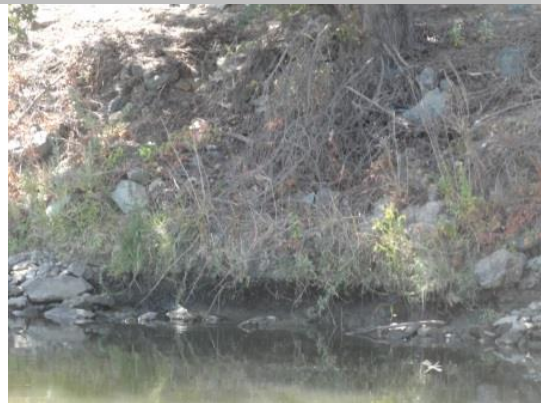
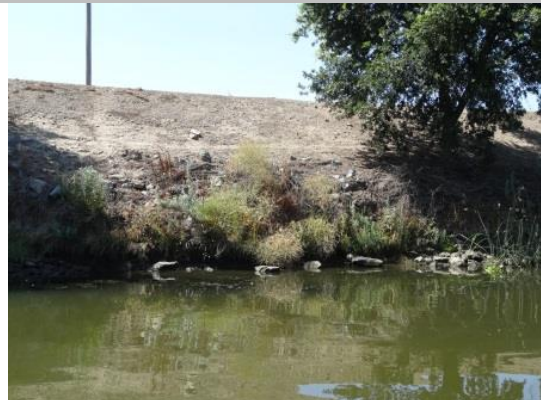
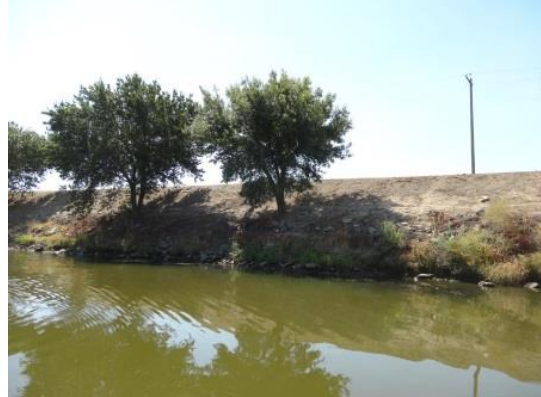
LM Start	0.10	Rating **	U	Issue No.	9
LM End	0.11	Issue Type +	Ma	Location *	WS
Category	Supplemental			GPS Latitude/Longitude	
				Start	End
Item	DWR Erosion Survey			37.810052 °	37.810052 °
				-121.388847 °	-121.388847 °
DWR ID					
Action/Comments					
Inspector Comments: 06/25/2015: No significant change observed. 07/02/2014: No significant change observed. 08/13/2013: No significant change observed. 08/07/2012: The site has been visited by boat survey. No significant change observed 08/23/2011: Hard to view the erosion because of the dense vegetation and trees on site. The site is under the bush, close to the tree. [2015 Site ID:RD2062U03RM30.02]

Close view of the site. Note the vegetation.

Front view of the site.

LM Start	0.10	Rating **	U	Issue No.	9 (cont)
LM End	0.11	Issue Type +	Ma	Location *	WS
Category	Supplemental			GPS Latitude/Longitude	
				Start	End
Item	DWR Erosion Survey			37.810052 °	37.810052 °
				-121.388847 °	-121.388847 °
DWR ID					
Action/Comments					
Inspector Comments: 06/25/2015: No significant change observed. 07/02/2014: No significant change observed. 08/13/2013: No significant change observed. 08/07/2012: The site has been visited by boat survey. No significant change observed 08/23/2011: Hard to view the erosion because of the dense vegetation

View of the site from downstream.

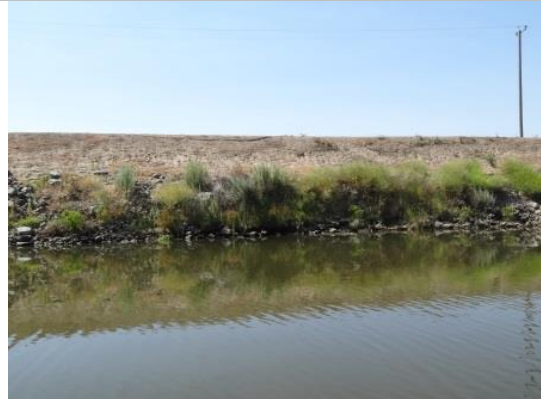
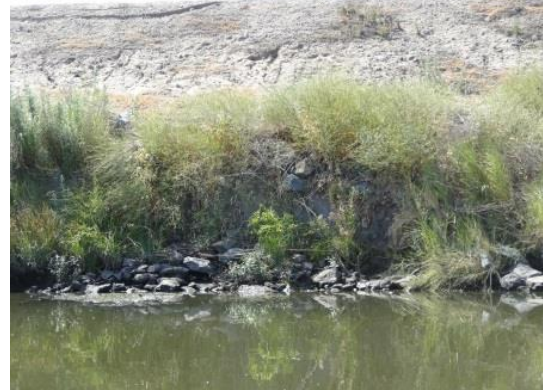
LM Start	0.18	Rating **	M	Issue No.	13
LM End	0.18	Issue Type +	Ma	Location *	WS
Category	Supplemental			GPS Latitude/Longitude	
				Start	End
Item	DWR Erosion Survey			37.810468 °	37.810468 °
				-121.387492 °	-121.387492 °
DWR ID					
Action/Comments					
Inspector Comments: 06/25/2015: No significant change observed. 07/02/2014: No significant change observed. 08/13/2013: No significant change observed. 08/07/2012: The site has been visited by boat survey. No significant change observed 08/23/2011: The protection at the levee toe has been washed away. [2015 Site ID:RD2062U03RM30.1]

Direct view of the site.

Close view of the erosion.

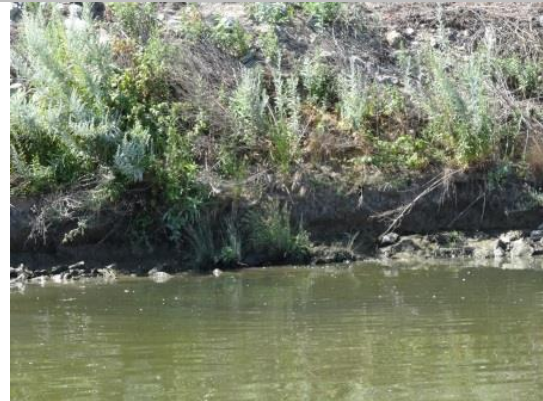
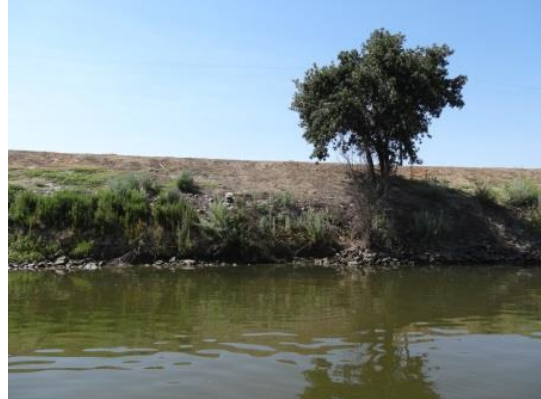
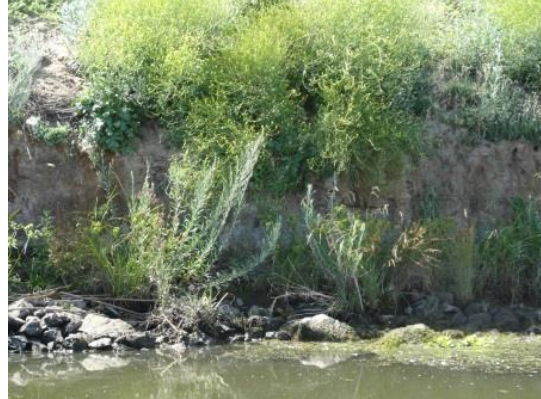
LM Start	0.22	Rating **	U	Issue No.	17
LM End	0.31	Issue Type +	Ma	Location *	WS
Category	Supplemental			GPS Latitude/Longitude	
				Start	End
Item	DWR Erosion Survey			37.810609 °	37.810609 °
				-121.385879 °	-121.385879 °
DWR ID					
Action/Comments					
Inspector Comments: 06/25/2015: No significant change observed. 07/02/2014: No significant change observed. 08/13/2013: A new pocket erosion at the upper levee slope has been found directly above a large tree. The erosion might have been caused by internal pipe leakage or surface runoff. 08/07/2012: The site has been visited by boat survey. No significant change observed 08/23/2011: No significant change observed on site. Dense vegetation is visible along the water line. 09/07/2010: No significant change observed on site. Much of the upper slope was recently cleared of vegetation by spraying. 4- to 6-foot vertical scarp and pocket erosions are lined along a span of 475 feet. In some sections, the vertical scarp encroaches into the levee prism. There is a lack of berm along this reach, exposing the levee slope to high flow velocities during normal and flood events. 08/06/2010: Recommended as local maintenance issue, per CLRO. 03/09/2010: As discussed with Michael Moncrief of MBK Engineers, the site will be 'addressed' later this year. 09/29/2009: No major change observed since last visit; pocket erosion and a vertical scarp forming; this site was combined with Site RM30.13 and 30.02 with a combined total erosion length of 475 feet; recommended as annual assessment and monitoring of the site, per CLRO CES Evaluation 2008 Report; previously rated "M". 11/05/2008: Top of vertical scarp has rip rap that appears to be sliding; rodent holes; existing toe rip rap. [2015 Site ID:RD2062U03RM30.19]

Front view of the existing erosion at the toe.

View of the pocket erosion and the tree.

Close view of the pocket erosion.

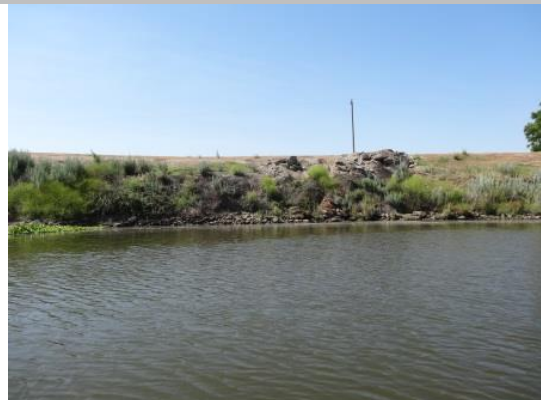
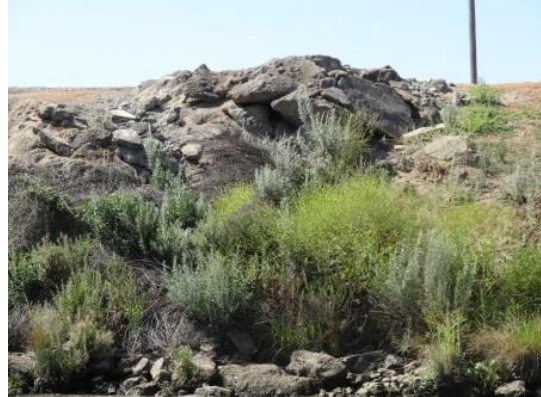
LM Start	0.35	Rating **	M	Issue No.	1
LM End	0.35	Issue Type +	Ma	Location *	WS
Category	Supplemental			GPS Latitude/Longitude	
				Start	End
Item	DWR Erosion Survey			37.811281 °	37.811281 °
				-121.384461 °	-121.384461 °
DWR ID					
Action/Comments					
Inspector Comments: 06/25/2015: No significant change observed. 07/02/2014: No significant change observed. 08/13/2013: No significant change observed. 08/07/2012: The site has been visited by boat survey. No significant change observed 08/23/2011: The site is right at the downstream of a river bend. [2015 Site ID:RD2062U03RM30.27]

Front view of the erosion.

Close view of the site. Note the piled concrete debris.

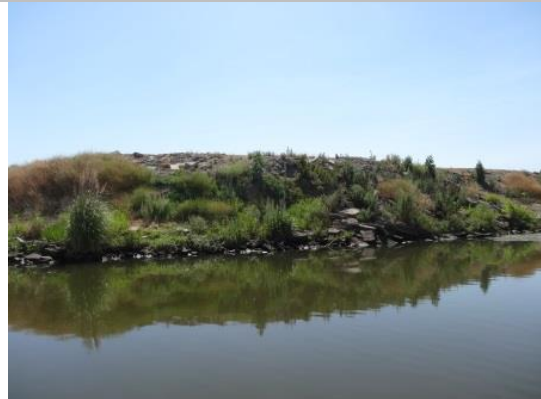
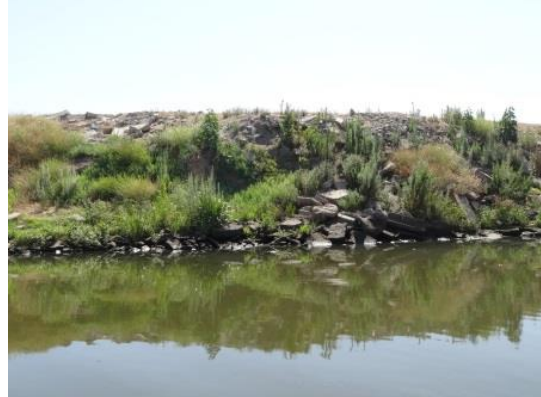
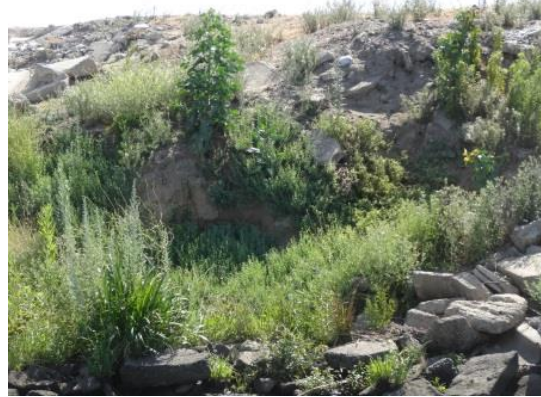
LM Start	0.55	Rating **	M	Issue No.	2
LM End	0.56	Issue Type +	Ma	Location *	WS
Category	Supplemental			GPS Latitude/Longitude	
				Start	End
Item	DWR Erosion Survey			37.813070 °	37.813070 °
				-121.383100 °	-121.383100 °
DWR ID					
Action/Comments					
Inspector Comments: 06/25/2015: No significant change observed. 07/02/2014: No significant change observed. 08/13/2013: No significant change observed. 08/07/2012: The site has been visited by boat survey. No significant change observed. 08/23/2011: No significant change observed on site. 09/07/2010: No significant change observed on site. Much of the placed rip rap revetment has slid. It is no longer adequately protecting the slope. 08/06/2010: Recommended as local maintenance issue, per CLRO Report. 03/09/2010: As discussed with Michael Moncrief of MBK, site will be 'addressed' this year. 09/29/2009: No major change observed since last visit; a section of the rip rap has slipped, exposing a levee section that has eroded; recommended as local maintenance issue, per CLRO CES Evaluation 2008 Report; Site # is the same as RM30.43, LM0.63; previously rated "U". 11/05/2008: Site is located inside of a bend; scarp looks to be into the levee prism; piles of concrete chunks placed on the slope, with some of them already starting to slide. [2015 Site ID:RD2062U03RM30.43]

Front view of the site.

Inspector Comments: 06/25/2015: No significant change observed.  
 07/02/2014: No significant change observed.  
 08/13/2013: No significant change observed.  
 08/07/2012: The site has been visited by boat survey. No significant change observed.  
 08/23/2011: No significant change observed on site.  
 09/07/2010: No significant change observed on site. Much of the placed rip rap revetment has slid. It is no longer adequately protecting the slope.  
 08/06/2010: Recommended as local maintenance issue, per CLRO Report.  
 03/09/2010: As discussed with Michael Moncrief of MBK, site will be 'addressed' this year.  
 09/29/2009: No major change observed since last visit; a section of the rip rap has slipped, exposing a levee section that has eroded; recommended as local maintenance issue, per CLRO CES Evaluation 2008 Report; Site # is the same as RM30.43, LM0.63; previously rated "U".  
 11/05/2008: Site is located inside of a bend; scarp looks to be into the levee prism; piles of concrete chunks placed on the slope, with some of them already starting to slide. [2015 Site ID:RD2062U03RM30.43]

Front view of the site. Previously placed rip rap slipped, exposing the underlying soils and creating a pocket.

Front view of the site. Rip rap no longer adequately protecting levee slope.

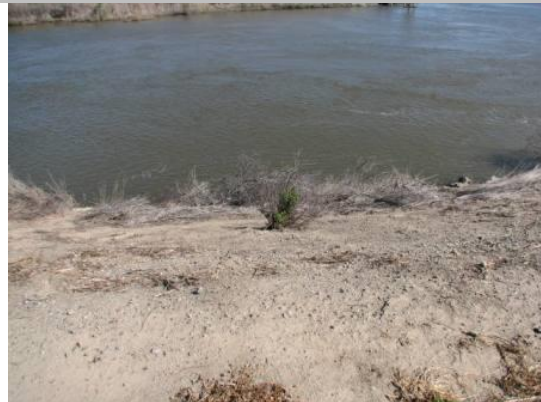
Photo 1 of 1 : FA\_2015\_RD2062\_311\_10\_20150910\_00009.jpg

LM Start	0.61	Rating **	N	Issue No.	10
LM End	0.61	Issue Type +	Ma	Location *	WS
Category	Earthen Levee			GPS Latitude/Longitude	
				Start	End
Item	Trim / Thin Trees			37.813570 °	37.813570 °
				-121.382094 °	-121.382094 °
DWR ID	DWR_RD2062_03_s_2012_10				
Action/Comments					
Tree stumps.					
Inspector Comments: Stump in slope.

05/11/2011 Stump in slope, new growth in center of photo is at the location of the stump.

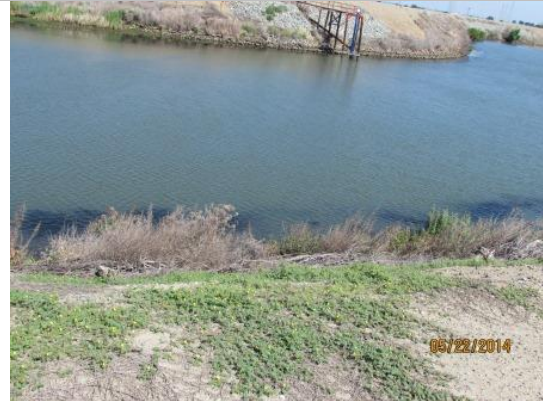
Photo 1 of 1 : FA\_2015\_RD2062\_311\_12\_20150910\_00012.jpg

View of the tree stumps on the waterside levee slope.

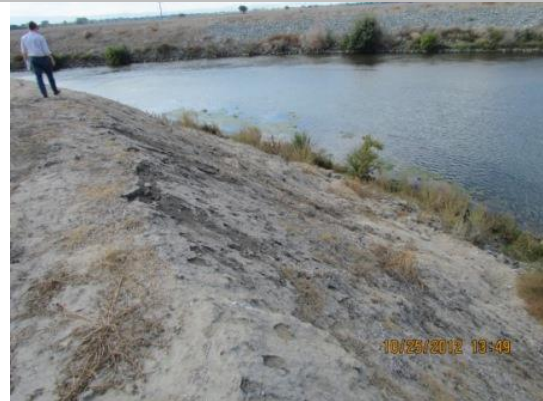
Photo 1 of 2 : FA\_2015\_RD2062\_311\_11\_20150910\_00011.jpg

LM Start	0.81	Rating **	A/W	Issue No.	11
LM End	0.81	Issue Type +	Ma	Location *	WS
Category	Earthen Levee			GPS Latitude/Longitude	
				Start	End
Item	Erosion / Bank Caving			37.816315 °	37.816315 °
				-121.381587 °	-121.381587 °
DWR ID	DWR_RD2062_03_s_2012_11				
Action/Comments					
Schedule repair of erosion site prior to the next inspection. Inspector Comments: Cracking developing along the waterside levee hinge.

View of slope erosion from foot traffic.

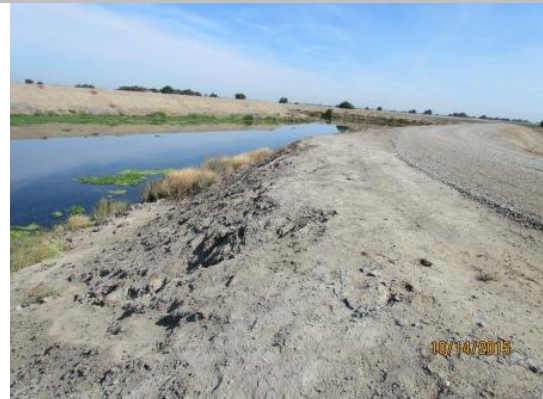
Photo 2 of 2 : FA\_2015\_RD2062\_311\_11\_20151026\_00028.jpg

View of cracking at waterside levee hinge.

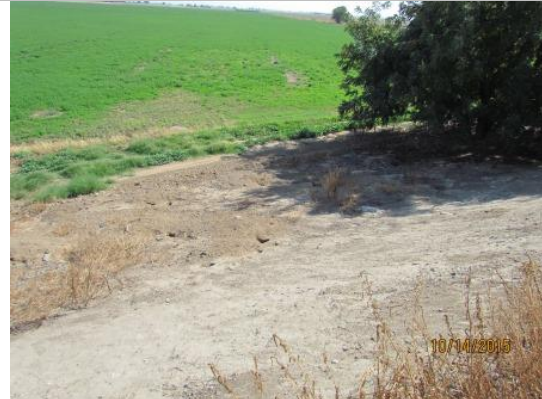
Photo 1 of 1 : FA\_2015\_RD2062\_311\_34\_20151026\_00027.jpg

View of the rodent burrows at the landside levee toe.

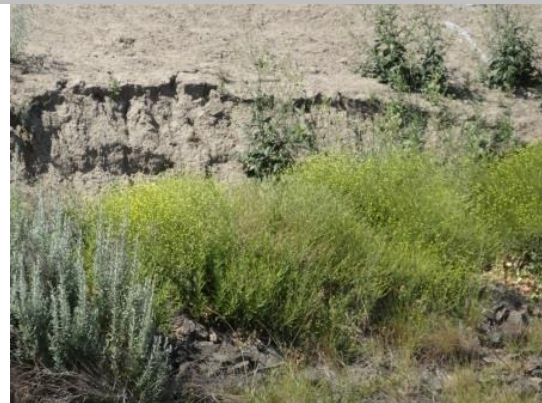
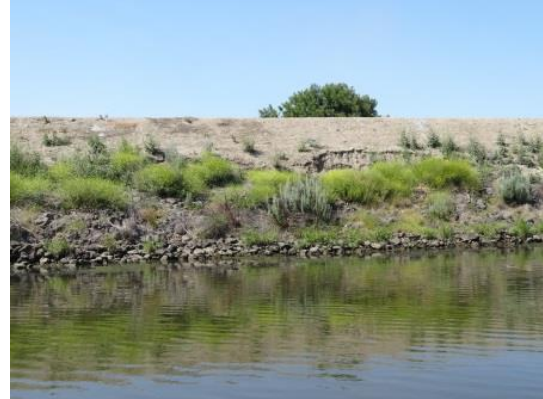
LM Start	1.18	Rating **	U	Issue No.	4
LM End	1.19	Issue Type +	Ma	Location *	WS
Category	Supplemental			GPS Latitude/Longitude	
				Start	End
Item	DWR Erosion Survey			37.819290 °	37.819290 °
				-121.378880 °	-121.378880 °
DWR ID					
Action/Comments					
Inspector Comments: 06/25/2015: No significant change observed. 07/02/2014: No significant change observed. 08/13/2013: No significant change observed. 08/07/2012: The site has been visited by boat survey. No significant change observed 08/23/2011: No significant change observed on site. 09/07/2010: No significant change observed on site. Much of the seasonal grass along the slope was cleared. Site consists of an existing scalloped erosion approximately 30 feet long by 5 feet wide at its widest opening. The lateral crack is extended outwards along the middle slope. There is a 1 to 2 feet of differential settlement that could further develop into a shallow slide. 08/06/2010: Recommended as local maintenance issue, per CLRO. 03/09/2010: As discussed with Michael Moncrief of MBK Engineer, site will be 'addressed' this year. 09/28/2009: No major change observed; section of rip rap has slipped, creating a terraced effect; dense vegetation growth; recommended as a local maintenance issue, per CLRO CES Evaluation 2008 Report; Site # is the same as RM31.12,LM1.25; previously rated "U". 09/14/2006: 1-2' into prism. [2015 Site ID:RD2062U03RM31.12]

Close view of the site.

Front view of the site.

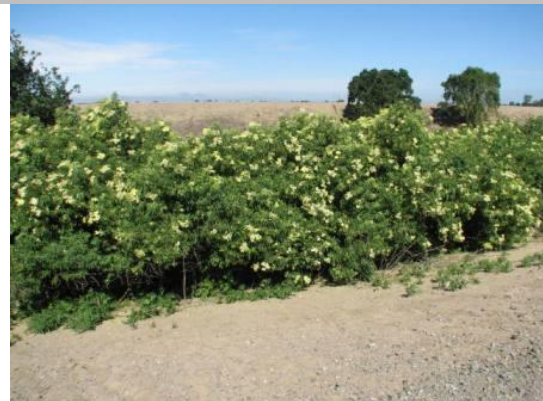
Photo 1 of 1 : FA\_2015\_RD2062\_311\_18\_20150910\_00015.jpg

05/11/2011 Elderberry bush on water side slope.

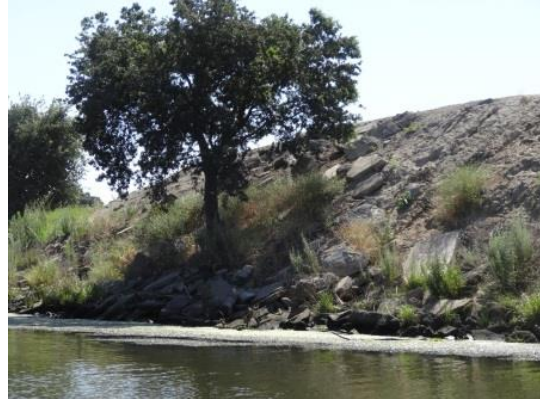
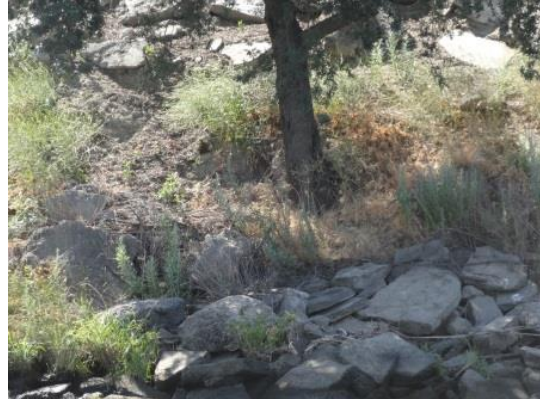
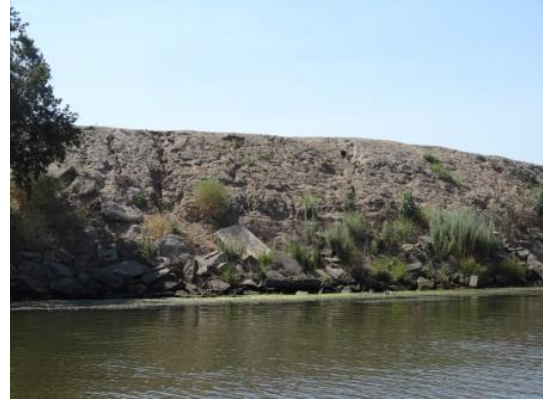
Inspector Comments: 06/25/2015: No significant change observed.  
 07/02/2014: No significant change observed.  
 08/13/2013: No significant change observed.  
 08/07/2012: The site has been visited by boat survey. No significant change observed  
 08/23/2011: No significant change observed on site.  
 09/07/2010: No significant change observed on site. There is a small-to medium sized Oak tree on the mid-slope just above rip rap. Some of the rip rap has collapsed, creating a pocket erosion just above the existing toe rip rap and upstream of the Oak tree.  
 08/06/2010: Recommended as local maintenance issue, per CLRO.  
 03/09/2010: As discussed with Michael Moncrief of MBK Engineer, site will be 'addressed' in 2010.  
 09/29/2009: No major change since last visit; sliding of the rip rap at the base of the lone tree; there is noticeable man-made trail and foot traffic extending from the crown to the toe; much of the broken concrete used as temporary rip rap has slid, exposing portion of the bare levee slope; recommended as local maintenance issue, per CLRO CES Evaluation 2008 Report; Site # is the same as RM31.3, LM1.45; previously rated "M".

Front view of the site. Note existing broken concrete on the upper slope as well as on the lower slope and at the toe.

A closer view of the site.

Front view of the site.

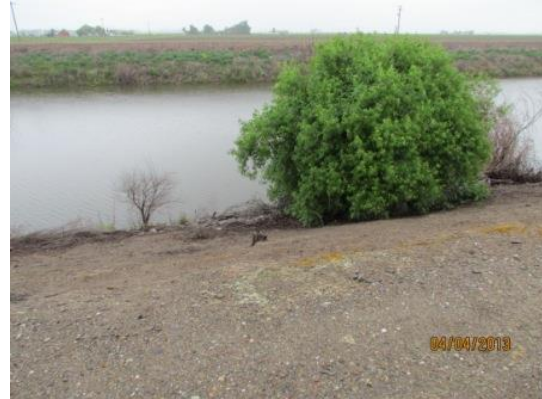
Photo 1 of 1 : FA\_2015\_RD2062\_311\_15\_20150910\_00014.jpg

View of the tree stump on the waterside levee slope.

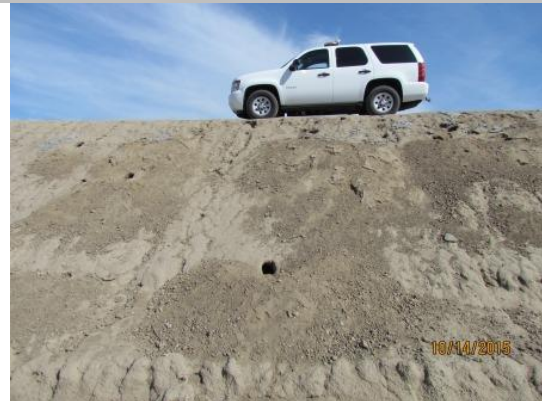
Photo 1 of 1 : FA\_2015\_RD2062\_311\_30\_20151026\_00026.jpg

View of the rodent hole on the landside levee slope.

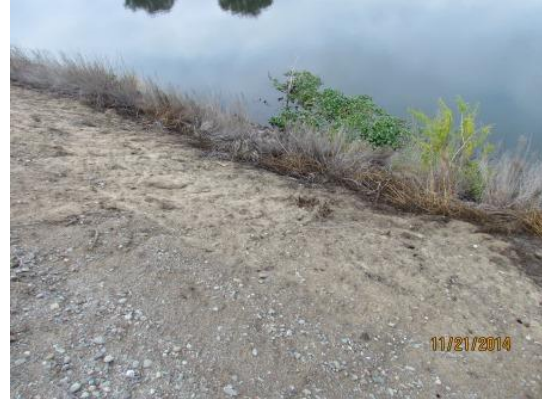
Photo 1 of 1 : FA\_2015\_RD2062\_311\_26\_20150910\_00018.jpg

View of the tree stump on the waterside levee slope.

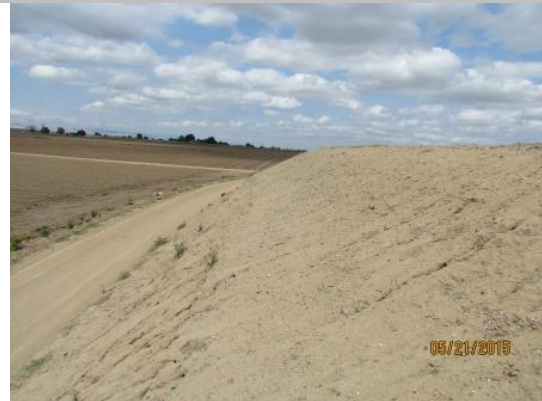
Photo 1 of 1 : FA\_2015\_RD2062\_311\_31\_20150910\_00019.jpg

LM Start	3.61	Rating **	M	Issue No.	31
LM End	3.66	Issue Type +	Ma	Location *	LS
Category	Earthen Levee			GPS Latitude/Longitude	
				Start	End
Item	Erosion / Bank Caving			37.816982 °	37.816541 °
				-121.342939 °	-121.342191 °
DWR ID	DWR_RD2062_03_s _ 2015_31				
Action/Comments					
Schedule repair of erosion site prior to the next inspection. Inspector Comments: About a 3 ft vertical cut at the levee toe into the levee prism.

View of the eroded landside levee toe.

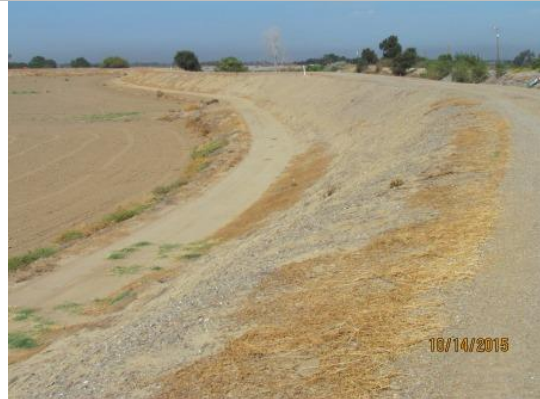
Photo 1 of 1 : FA\_2015\_RD2062\_311\_29\_20151026\_00025.jpg

View of the acceptable vegetation control on the landside levee slope.

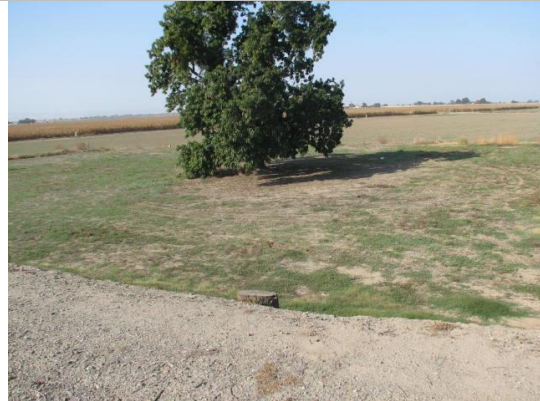
Photo 1 of 1 : FA\_2015\_RD2062\_311\_7\_20150910\_00006.jpg

10/21/2011 Photo taken the next day. Stump can be seen in the lower center of the photo.

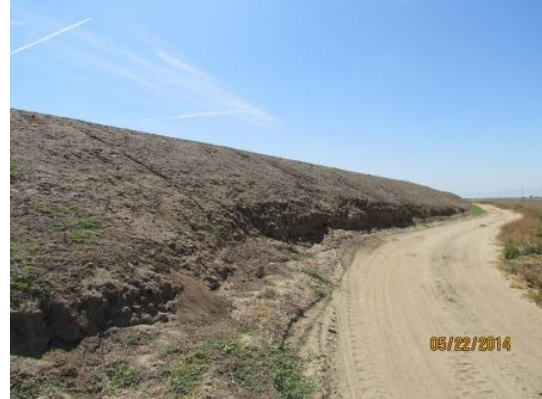
Photo 1 of 1 : FA\_2015\_RD2062\_311\_35\_20150910\_00021.jpg

View of a 2-3 feet vertical cut at the landside levee toe.
